Docket No. 217 – Development and Management Plan Inspection

Northeast Utilities Service Company Certificate of Environmental Compatibility and Public Need for the construction of a 345-kV electric transmission line and reconstruction of an existing 115-kV electric transmission line between Connecticut Light and Power Company's Plumtree Substation in Bethel, through the towns of Redding, Weston, and Wilton, and to the Norwalk Substation in Norwalk, Connecticut.

Date: December 12, 2003

Location: Norwalk Substation Expansion

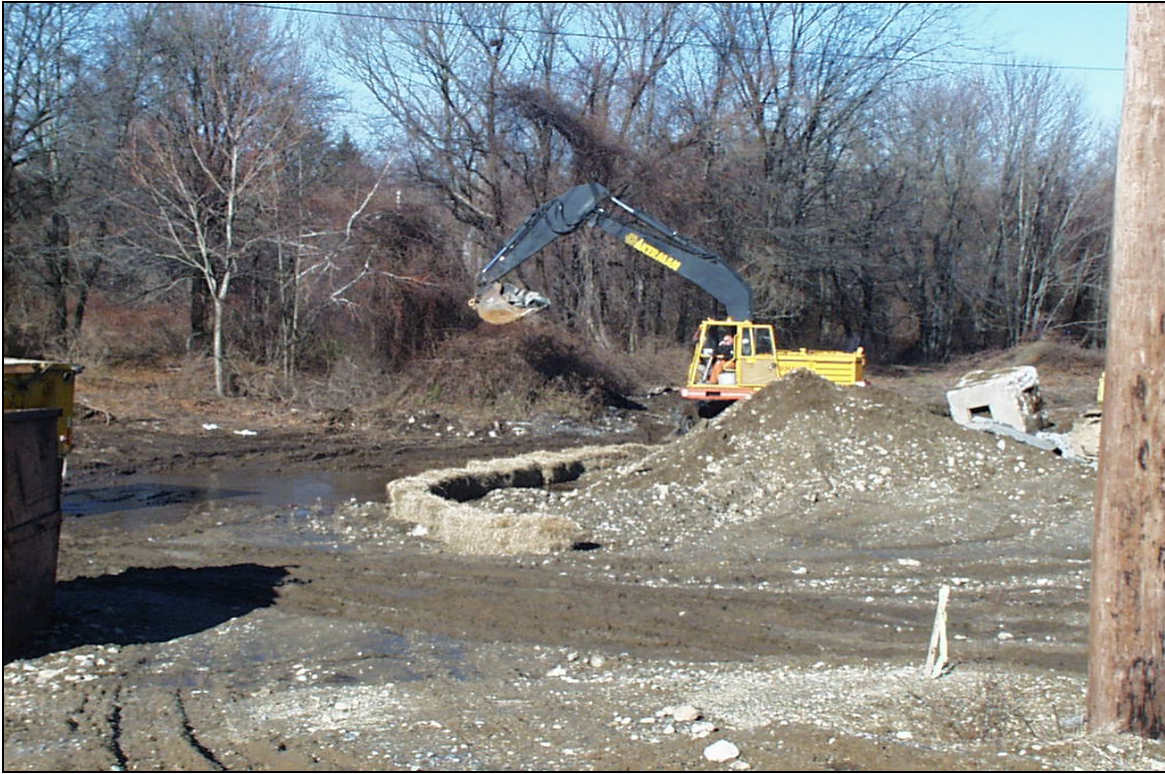
| Areas of Inspection | Observation | Recommended Action |
|---|---|--|
| | - Some small soil stockpiles located at the base of the slope leading from the access road were contained with haybales. 12/12/03 | - Temporary haybales were placed and are controlling sediment. Continue to monitor and maintain as needed 12/12/03 |

HAYBALES WERE PLACED AT THE BASE OF THE SMALL SOIL STOCKPILES
LOCATED NEAR THE BASE OF THE ACCESS ROAD. MUDDY CONDITIONS
WERE CREATED DUE TO THE RAIN 12/12/03

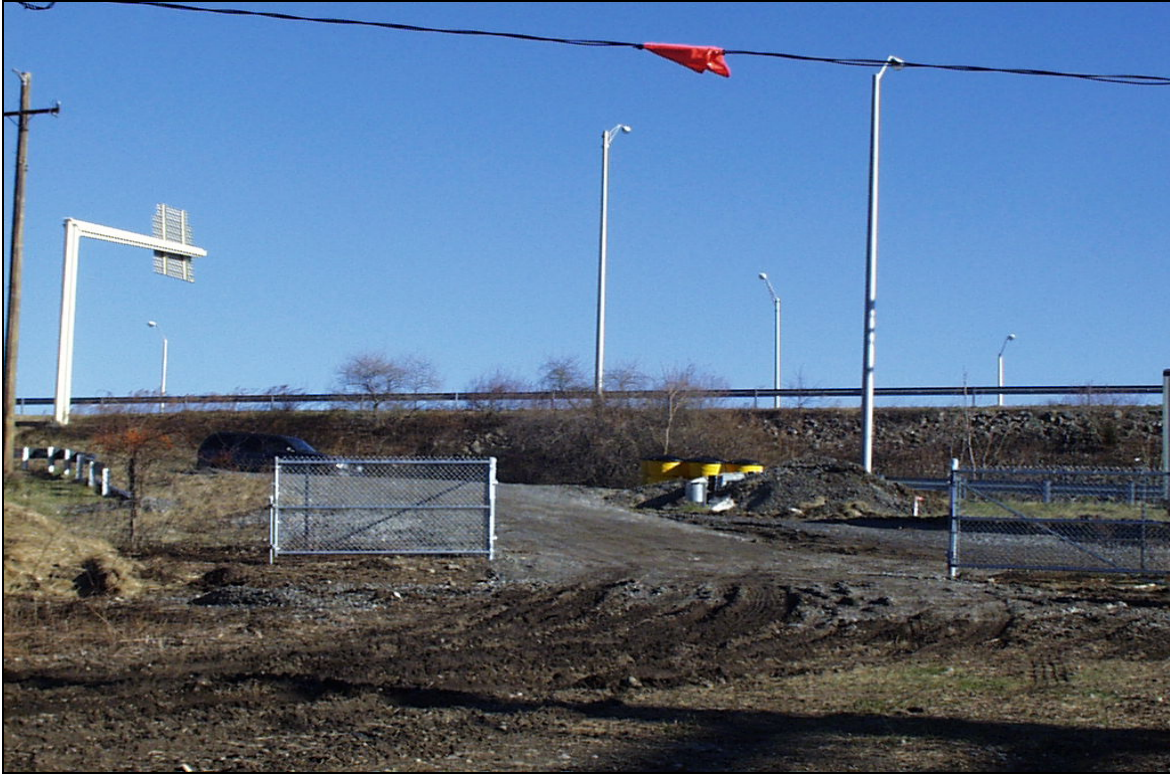
| Areas of Inspection | Observation | Recommended Action |
|---|---|--|
| Access Roads | - New access road off Route 7 ramp actively in use. No issues with erosion were noted at this time 12/12/03 | - None at this time, continue to monitor 12/12/03 |

THE ACCESS ROAD AT ROUTE 7 RAMP IS ACTIVELY IN USE AND THE GRAVEL BASE WAS INSTALLED OVER THE DIRT. 12/12/03

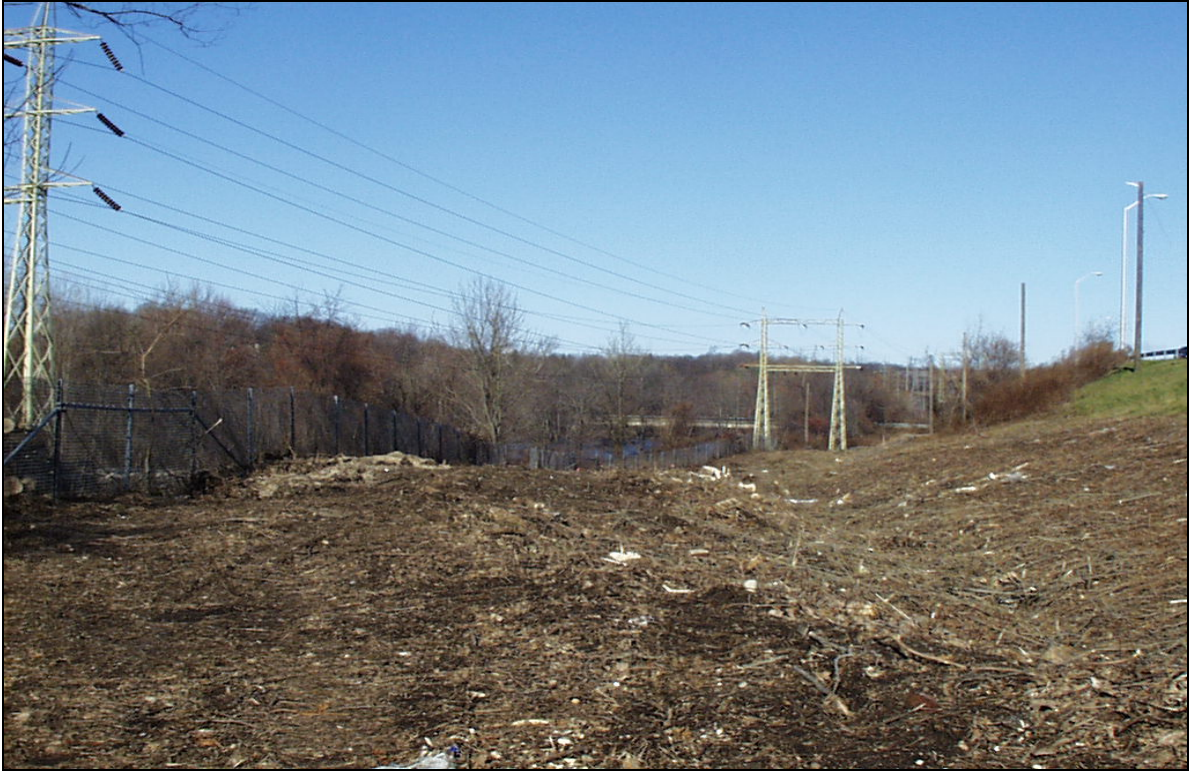
| Areas of Inspection | Observation | Recommended Action |
|--|---|--|
| Vegetative clearing limits (including trees to save or danger trees noted) | - Additional clearing has been completed near the Route 7 ramp to serve as the ROW for the pole relocation. Pole installation work was being performed at this time. 12/12/03 | - None at this time 12/12/03 |

VIEW LOOKING ALONG THE BASE OF THE ROUTE 7 RAMP AT THE
RECENTLY CLEARED AREA SERVING AS THE POLE RELOCATION RIGHT OF
WAY. 12/12/03
